## Using Infrared Thermography to Assess Moisture Problems

By: Josh Bate, President

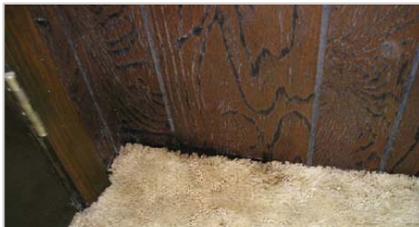
**Moisture Penetration Problems:** The use of infrared thermography makes it possible to find areas of hidden moisture within a building where mold growth is likely to occur. The two photos below show how thermal images are used during moisture assessments. The Owner complained of a strong mildew odor in the building and claimed there was not any water leakage.

*By using infrared thermography we are able to pinpoint the location of water penetration into the wall and show area of saturation.* Further investigation revealed hidden fungal amplification both inside of the wall and under the carpeting. The problems were corrected and the odors were alleviated.

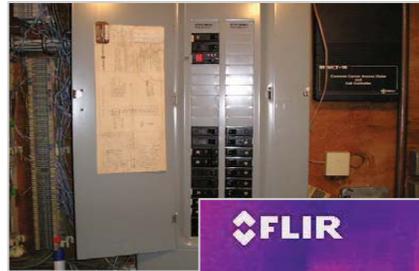
**Electrical and Fire Hazard Problems:** It was noticed during a commercial inspection of an office/warehouse that lights were flickering when other lights were turned on. *By looking at the electrical distribution panel we were able to easily spot the problem circuit.* Further investigation revealed that the circuit breaker was undersized for the intended application and was double tapped. This presented a fire hazard and shock hazard.

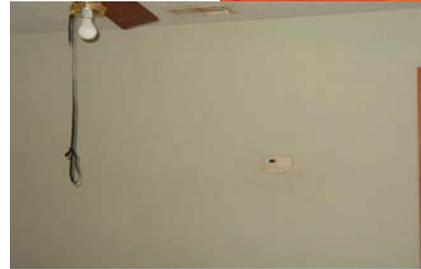
Pressure variances inside the building, i.e., pressurization or depressurization, can greatly affect the running time of the HVAC system. Since the HVAC is the largest energy user in the modern building, extended running time can be a significant factor in energy consumption.

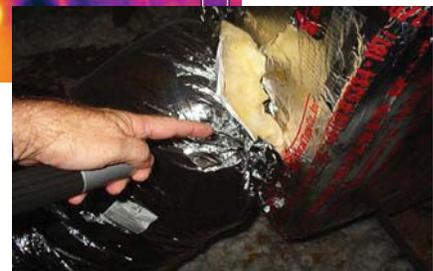
Return system leaks can greatly increase the amount of time that the HVAC system runs. If the return ducts are in the attic space, hot, moist air can be drawn into the system, causing extended running times. The infrared shows the temperature of the coil that is visible inside the air handler at 44.2°F. The air in the attic was over 80°F. This leak was found by scanning the plenum with the infrared thermal imaging camera and noting the cold spot.
